POLLARD ENTITIES

# 3670 WOODLAND PARK AVEN

ARCHITECTURAL REVIEW COMMITTEE BRIEFING  
December 10, 2021

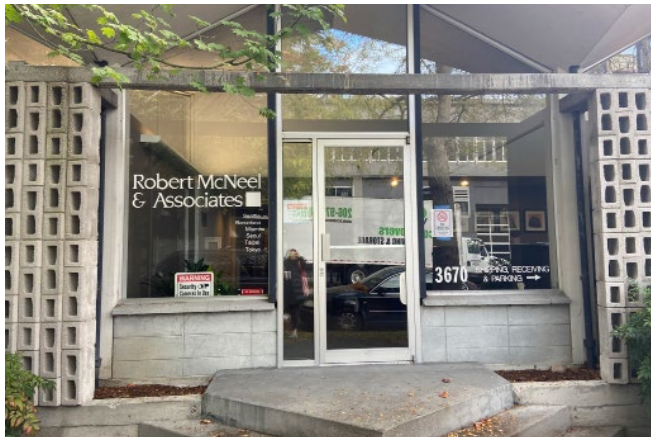
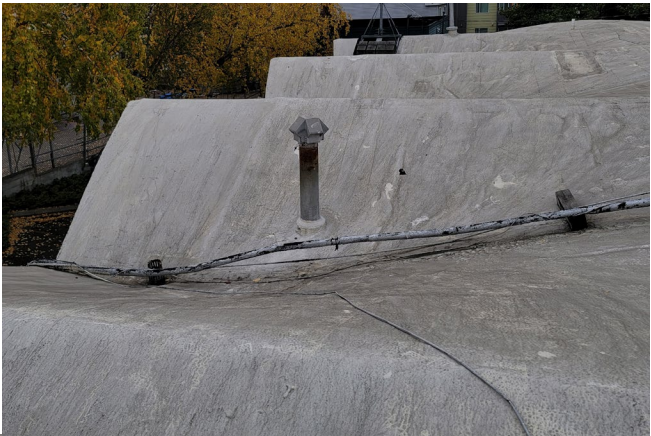
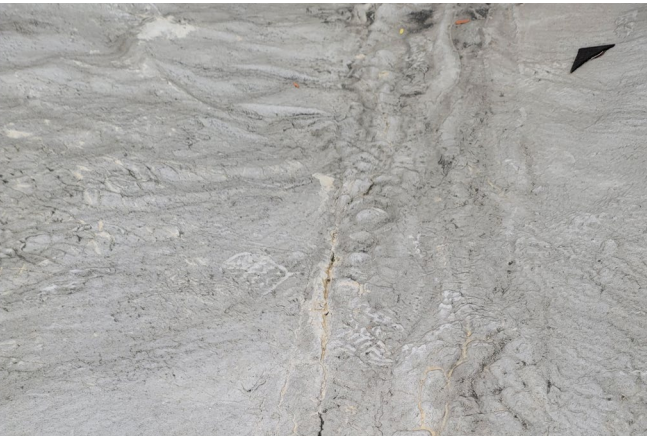
Existing roof condition

The current ownership has periodically had the roof areas cleaned, but has begun to have severe leakage problems primarily around the iron drain lines and the penetrations. There have been several attempts at repair without any long-term solutions. Currently the iron drain lines that are encased in the concrete support columns have been inspected and is noted severe rust and deterioration within the columns. It also has been noted that some of the columns are showing signs of cracking and spalling which is an indication of deterioration of the interior structural steel rebar and support steel.

The various old galvanized duct work and flashings have deteriorated beyond just a maintenance fix. These integral galvanized flashings have gone past the designed life of these materials. There are areas built into the roof structures. Sealants at ducting connections have all failed beyond simple maintenance.

The complete roof system has become damaged due to negligence. The membrane roofing requires a significant rebuild of the waterproofing, membrane, rusted and deteriorating metal connections and hardware. Numerous repair patches failed causing immediate damage to the concrete and steel reinforcing. The movement in the structure, the inability for the roofing to withstand expansion and contraction are causing splitting of the roof.

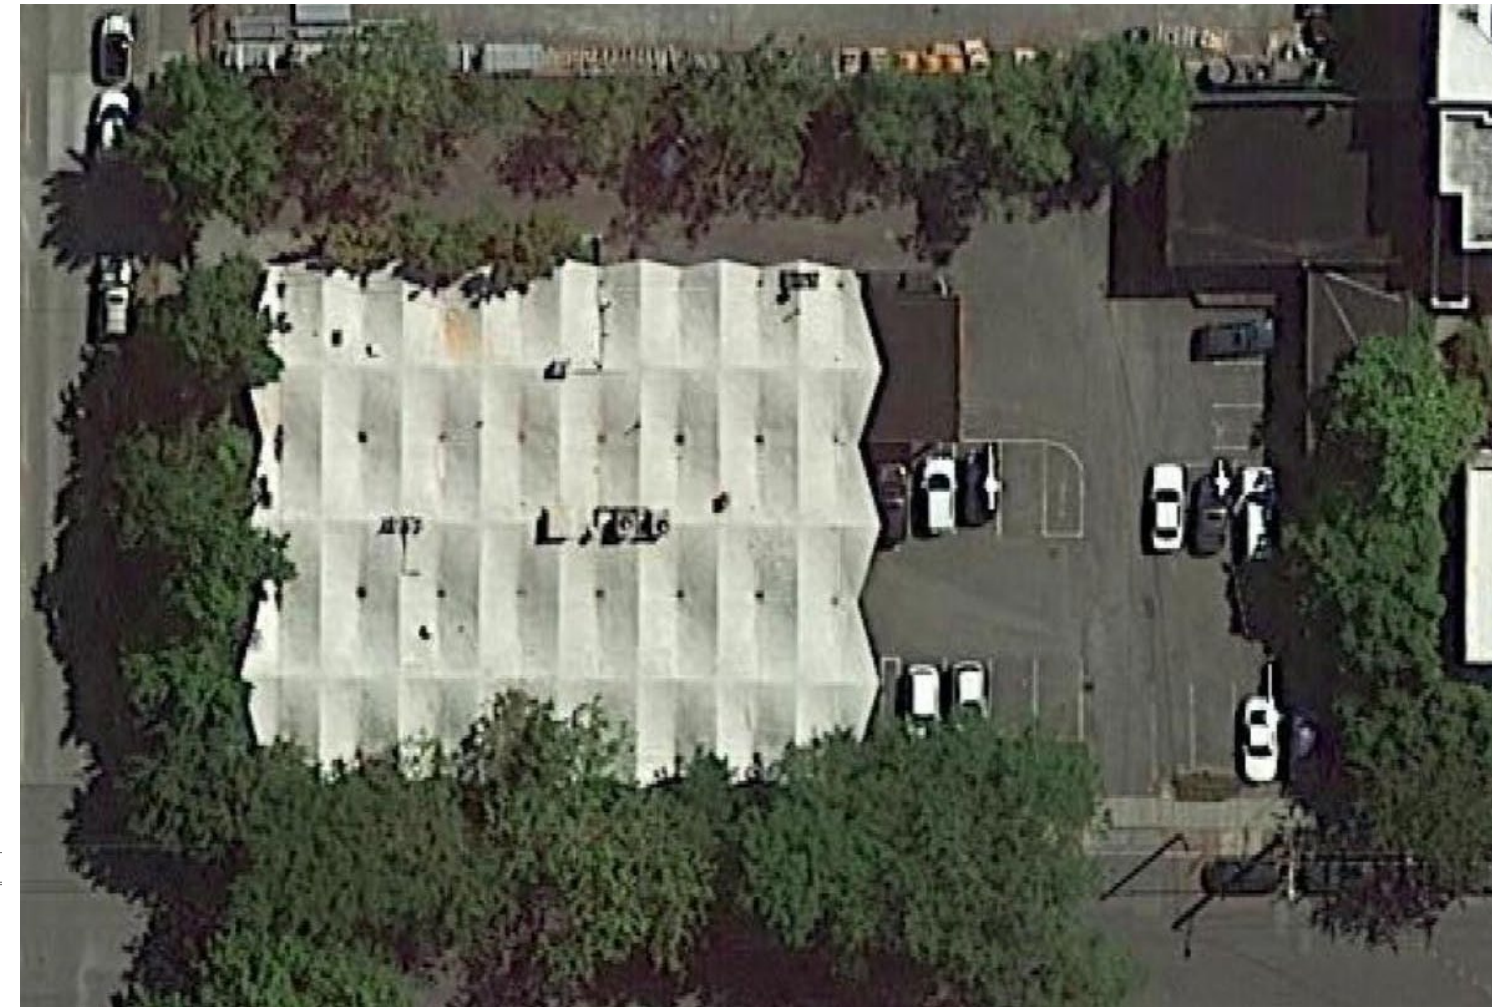
**EXISTING SITE PLAN**  
1/32" = 1'-0" SCALE

A dense covering of foliage showcases the site's presence within the neighborhood, boasting some of the larger trees in the vicinity.

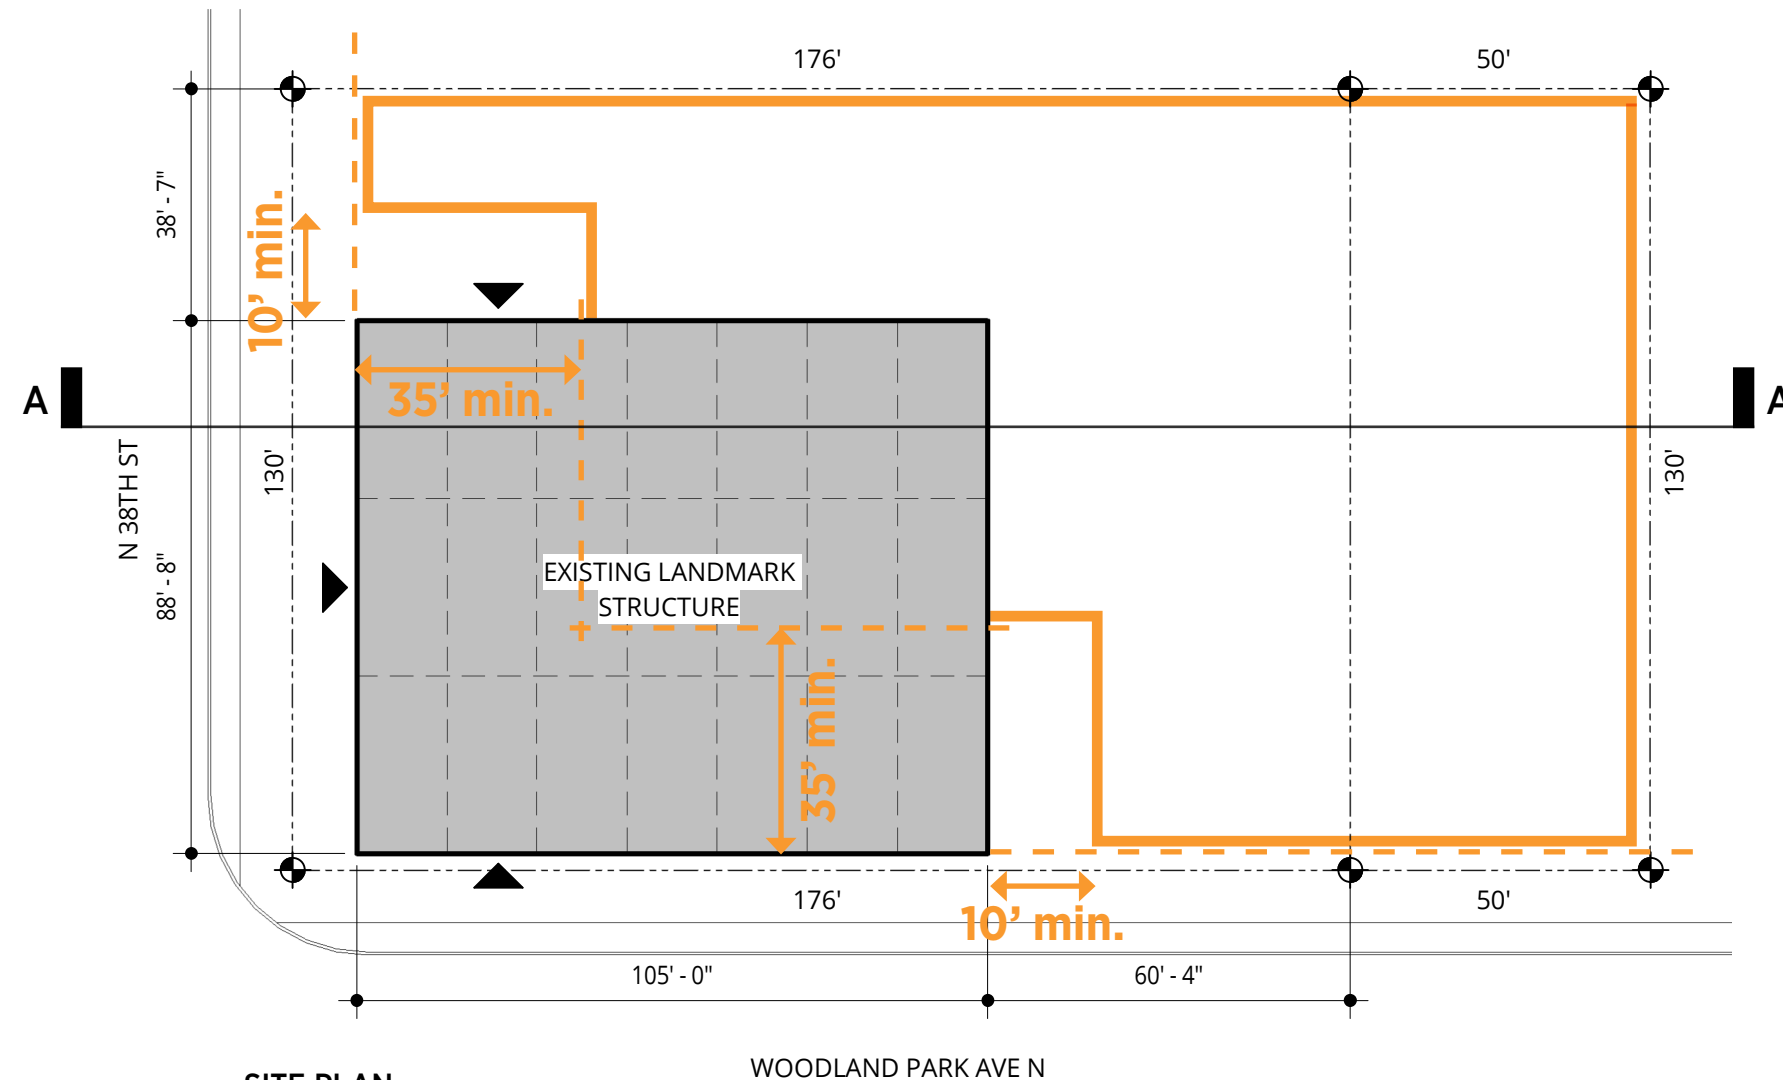
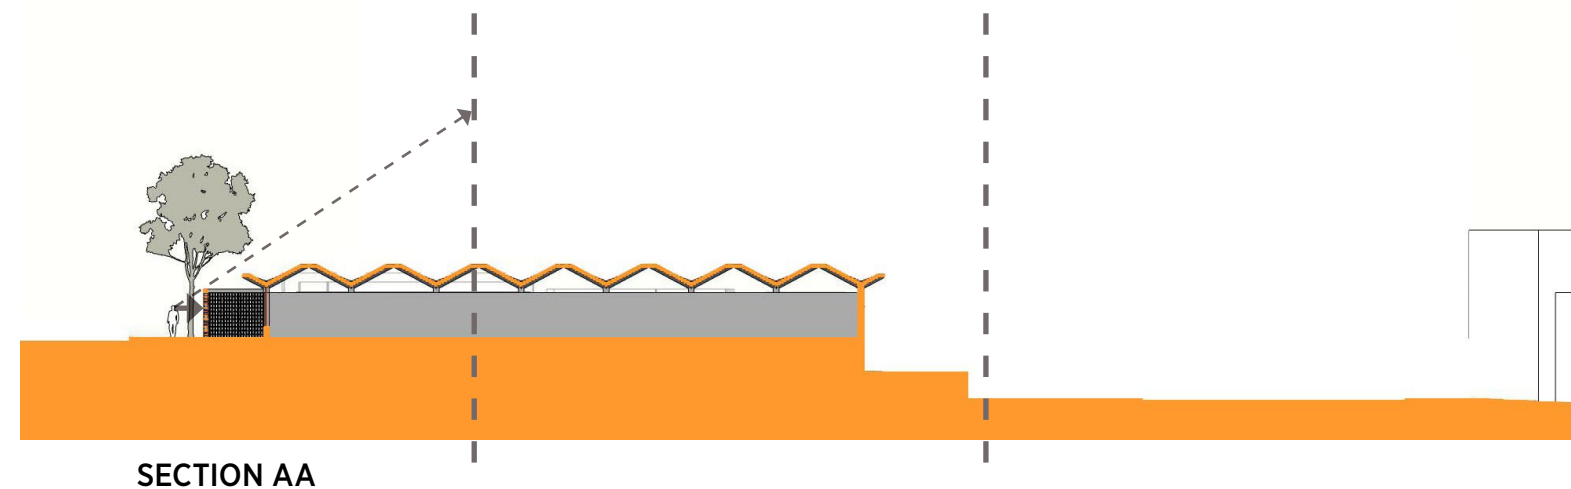
- heavy foliage provides natural screening of new development
- pedestrian focus remains on screen wall at sidewalk

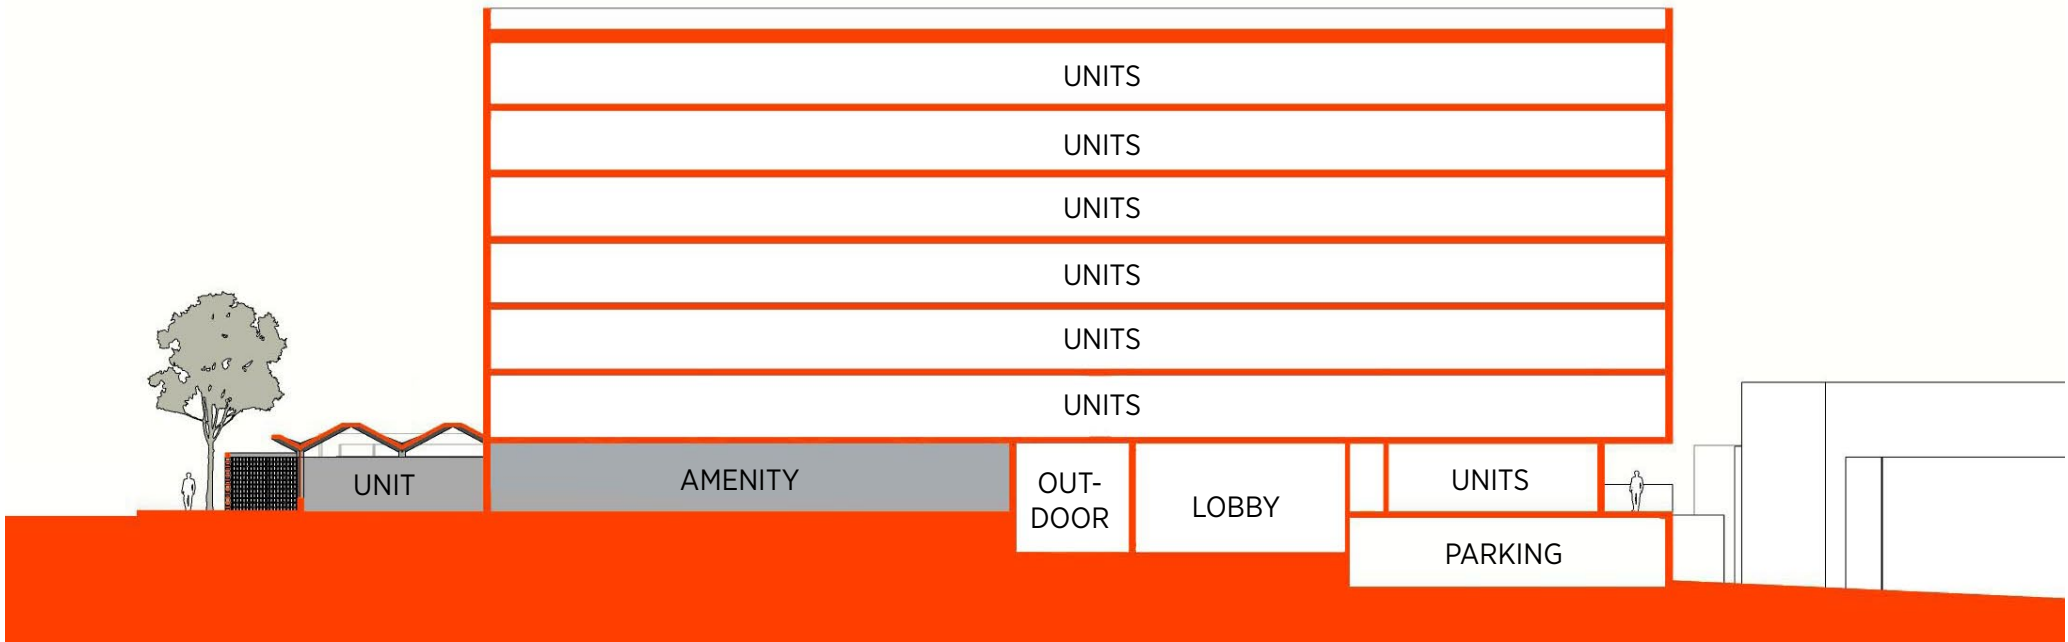
“ENGAGE” NORTH/SOUTH SECTION

- Option 01 is a solution which looks to engage directly with the existing building.
- The addition replaces a portion of the existing structure providing much needed structural and systems upgrades.
